## **Historic Environment Assessment**

GMSF Land  
Allocations, Trafford  
GMA46 Timperley  
Wedge

Appendix 4 (Historic  
Landscape)

**Report No:**  
2020/5

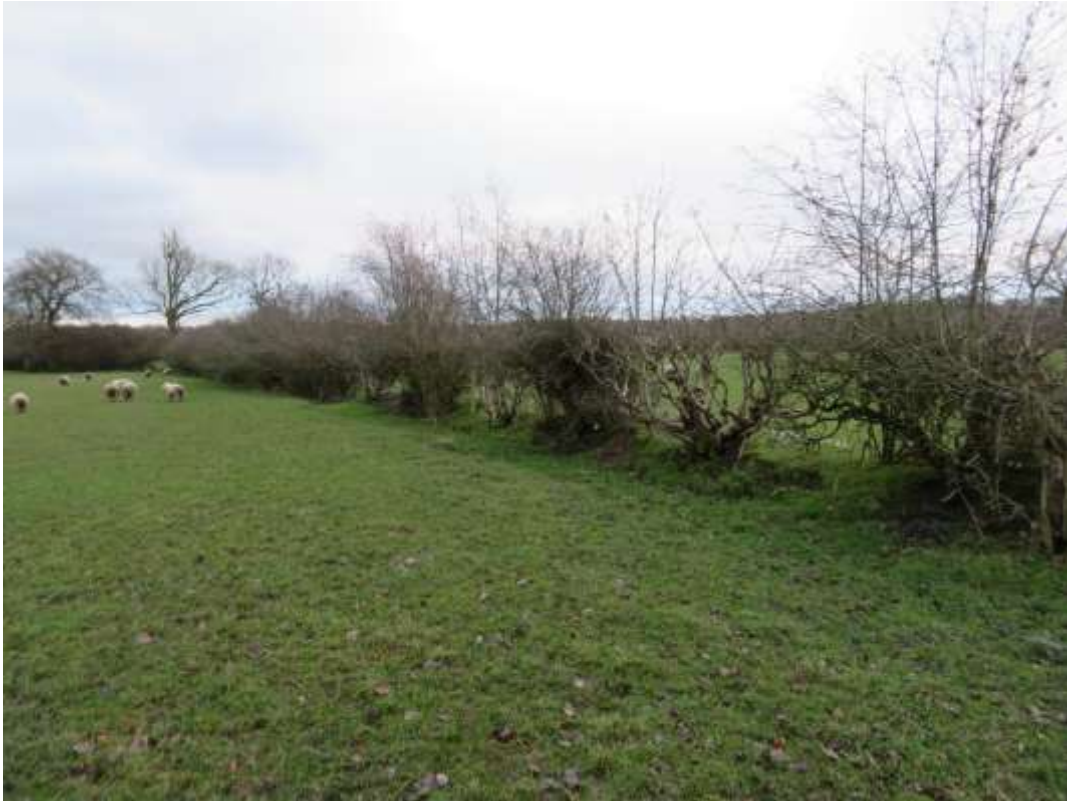
*Plate 1 Example of a historic field boundary within the Site. The remnants of the bank and outline of the ditch shows that this boundary has barely altered since the Post-Medieval period. (See Figure 3 for location)*

Those field boundaries are recommended for retention and incorporation as part of the green infrastructure of the area. The rapid assessment has shown that in some areas of the Site, particularly the former deer park, there appears to be a high species diversity and trees were noted in several hedgerows. Many also have surviving banks and ditches and reflect the piecemeal enclosure of the landscape after the deer park had been disimparked. This means that a number of the hedgerows in this area are likely to have pre-Inclosure Act origins, and may thus have the potential to be considered as 'Important' under the Hedgerows Regulations 1997. It should be noted however that consideration of 'Importance' under the Hedgerow Regulations 1997 falls outside the scope of this assessment and so if clarity on this matter is needed than a detailed hedgerow analysis should be commissioned.

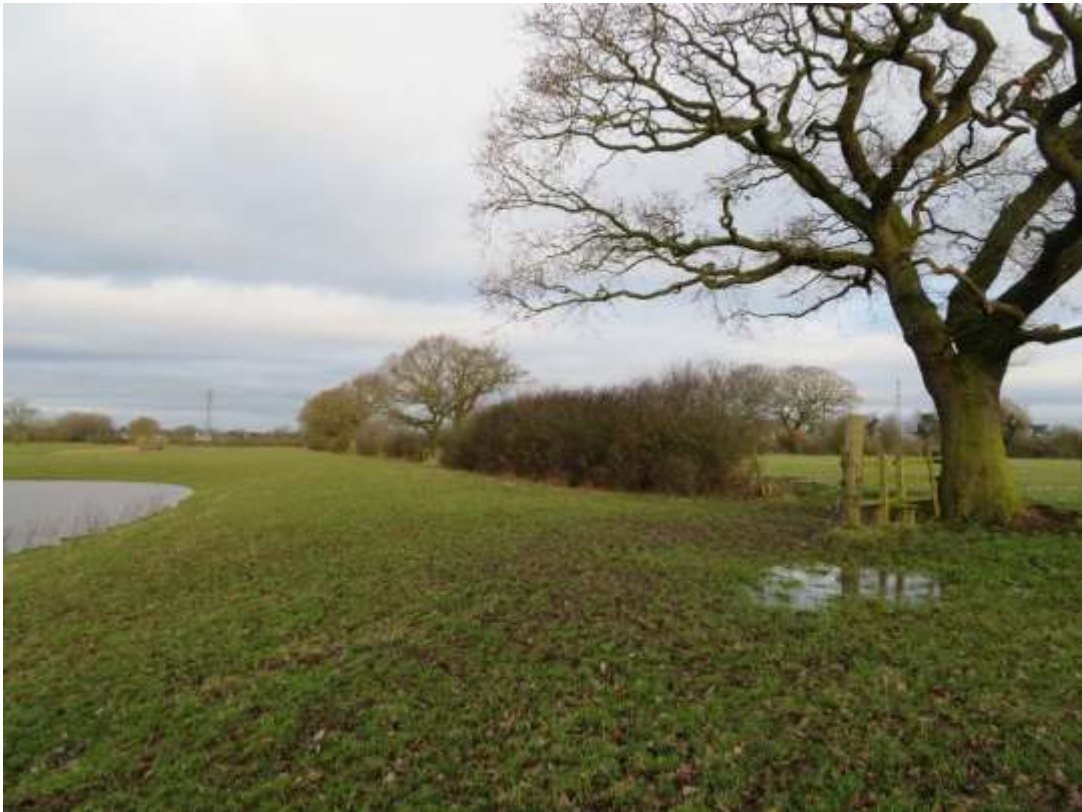
The upstanding remains of the park pale are represented by a small bank with an interior ditch running from the south side of Whitecarr Lane, with a number of mature trees and multiple plant species and has been traced over a distance of around 450m from NW-SE (NGR 379994, 387203 to 380216, 386880). The feature probably had a fence atop the bank originally and the interior ditch was also dug to prevent deer from leaping out of the park. Its condition varies along its course, with the ditch not present all along the interior of the bank and signs of erosion along the bank itself. Nevertheless, the bank does not appear to be a continuous feature and where it does survive, it is only slight in nature.

*Plate 2 The surviving park pale boundary, looking north. Note the presence of mature trees and remains of a bank. Also shown is the possible remains of a fish pond to the left (see Figure 8 for location)*

The potential for scheduling surviving features of the deer park have already been discussed in Appendix 2. The moated site, possible fishponds and the surviving park pale should be subject to conservation management plans to identify ways to protect them and prevent future damage and erosion. This could involve archaeological excavation and the opportunities to involve the local community have already been highlighted in Appendix 2. They should be preserved and presented as part of future development. A buffer should also be applied along the eastern side of the surviving part of the boundary and development should be avoided close to the boundary.

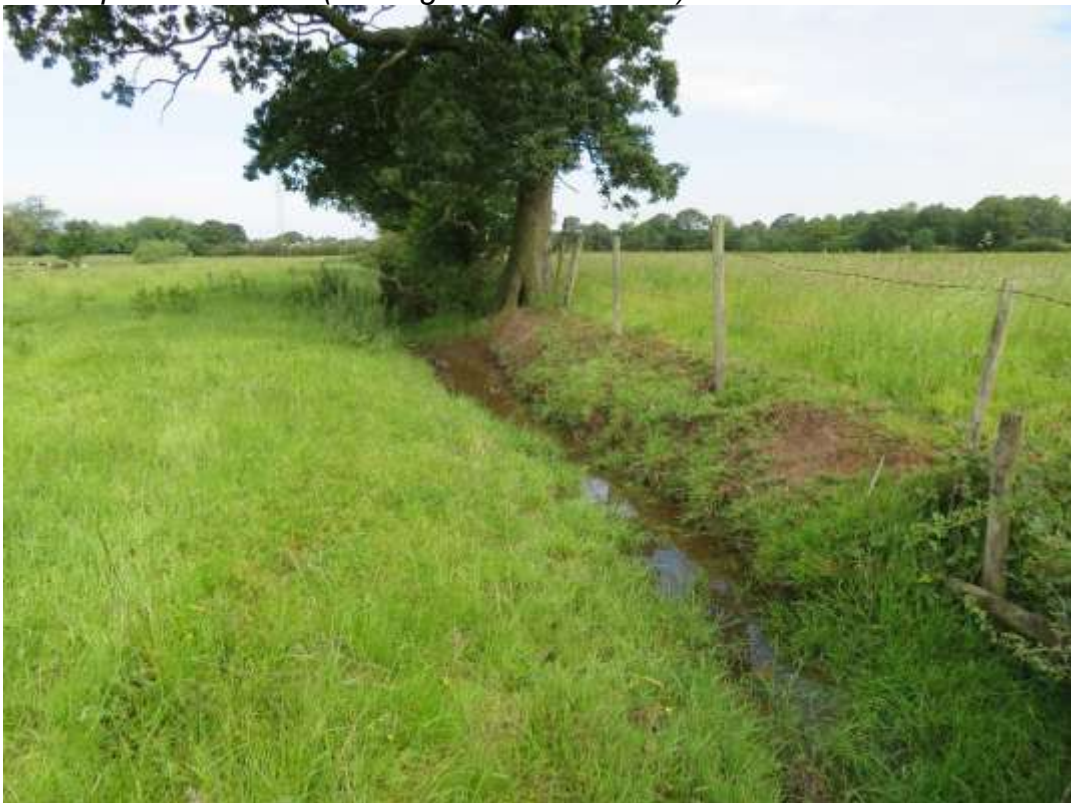
*Plate 3 Looking north along the bank and the interior ditch, which survive in places along the park pale (see Figure 8 for location)*

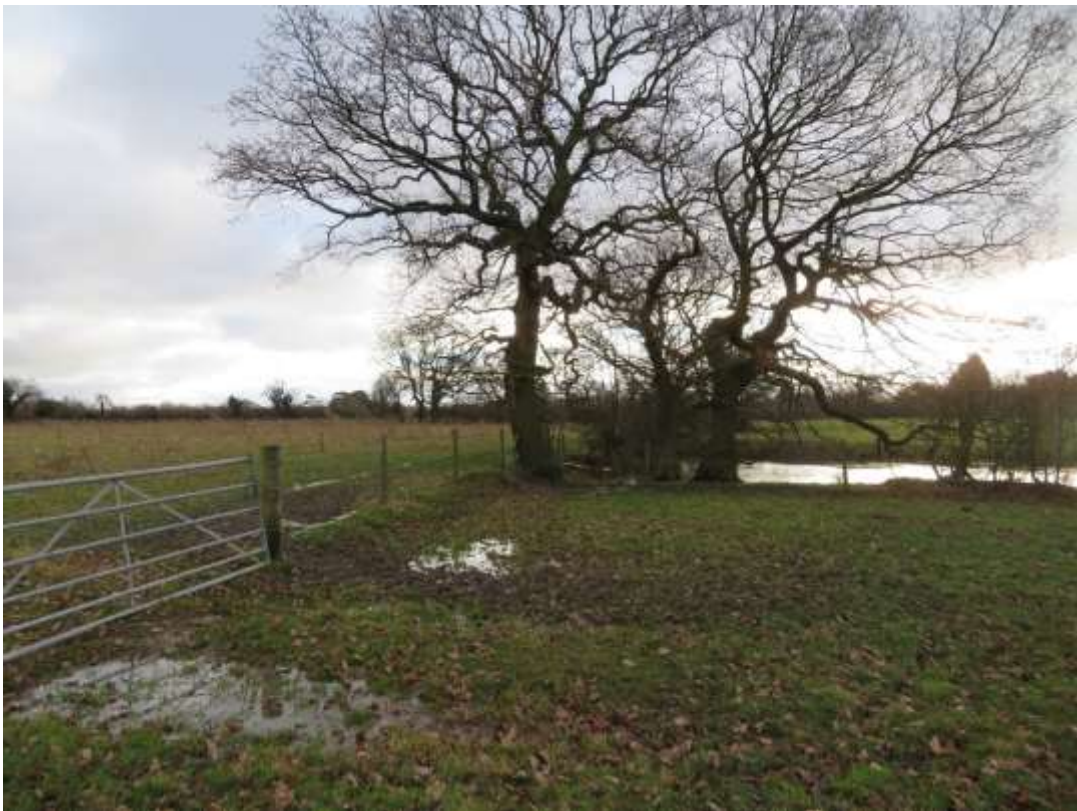
It is not clear where the park boundary would have been beyond its confirmed course to the south. There is a break in the boundary where the path from Roaring Gate Farm comes in from the east and it seems likely that it would have continued south along here. The hedgerow along this section is more broken, however there is a slight bank surviving in places (see Plate 4 and Figure 8 for location), as well as indications of a ditch elsewhere (see Plate 5 and Figure 8 for location). Its course beyond this, to the east of Buttery House Farm, cannot be confirmed although there are historic field boundaries within this area. However, the exact course of the boundary could be revealed through archaeological investigation.

*Plate 4 This is thought to be the continuation of the deer park boundary beyond its confirmed course. A slight bank can be seen where the boundary is fenced (see Figure 8 for location)*

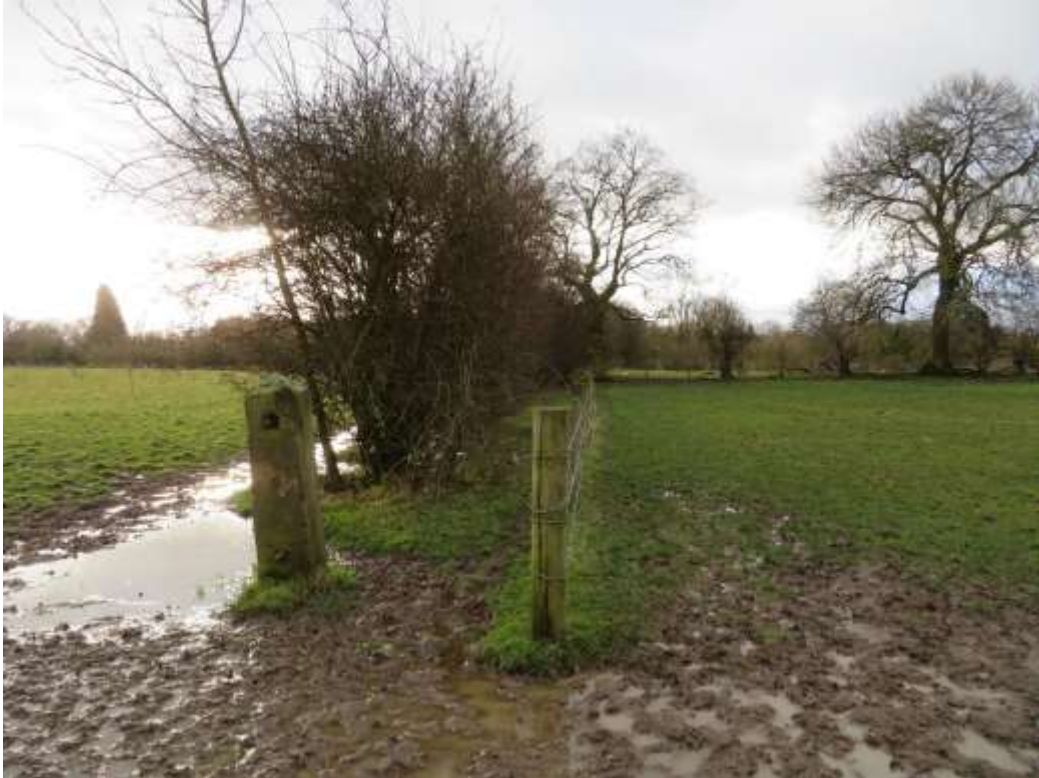
*Plate 5 Possible continuation of the deer park boundary. Here the waterlogging along the hedgerow could indicate the presence of a ditch although there is little trace of a bank (see Figure 8 for location)*

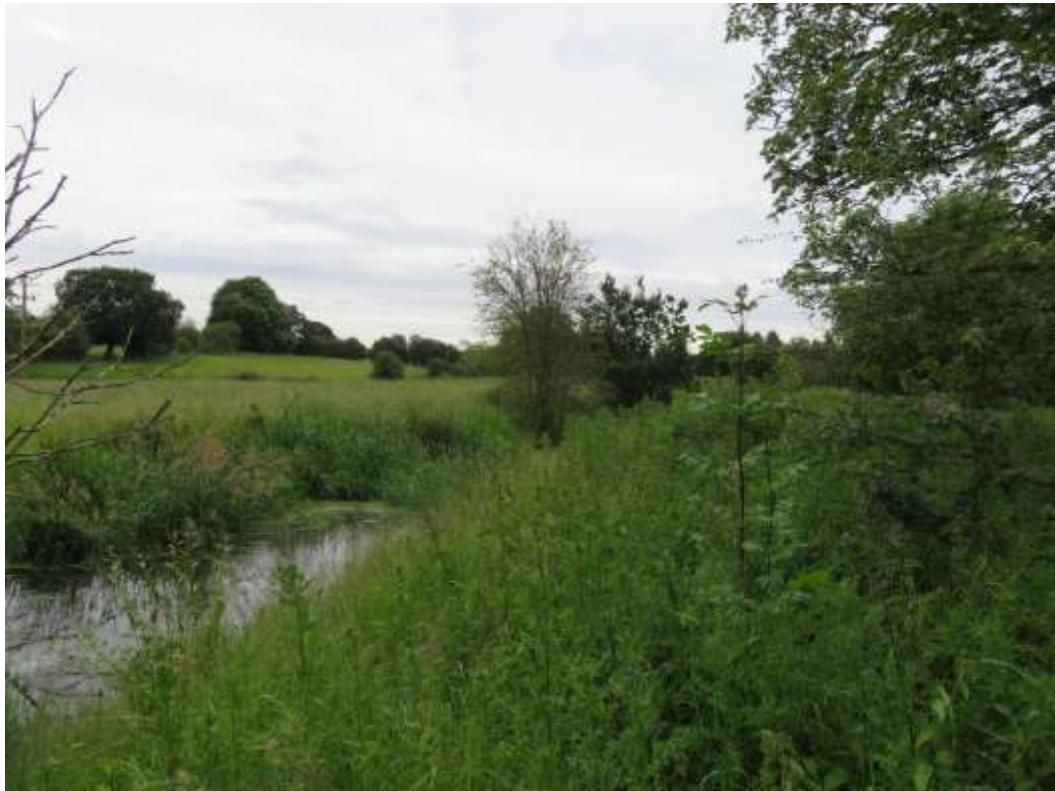
The archaeological detail on the moated site is detailed within Appendix 2. It consists of a relatively flat platform and the northern, and parts of the eastern and western arms of the moat, still survive as substantial water filled features. A public footpath/track crosses the moated site and appears to have been levelled up at some stage, possibly with demolition material from the farm. It has been ascertained from the site visits that the track does not form the southern part of the moat as had been previously thought. The western arm can be seen continuing southwards as a shallow depression which when visited in January 2020, had become waterlogged. In addition, the continuation of the eastern arm is hinted at by the presence of water, however it cannot be traced as a visible feature in the landscape. Other features that still survive, related to the later use of the farm, include stone gateposts which can be seen, currently obscured by hedgerows.

*Plate 6 The northern arm of the moat at Buttery House Farm survives and is water-filled, looking north-east*

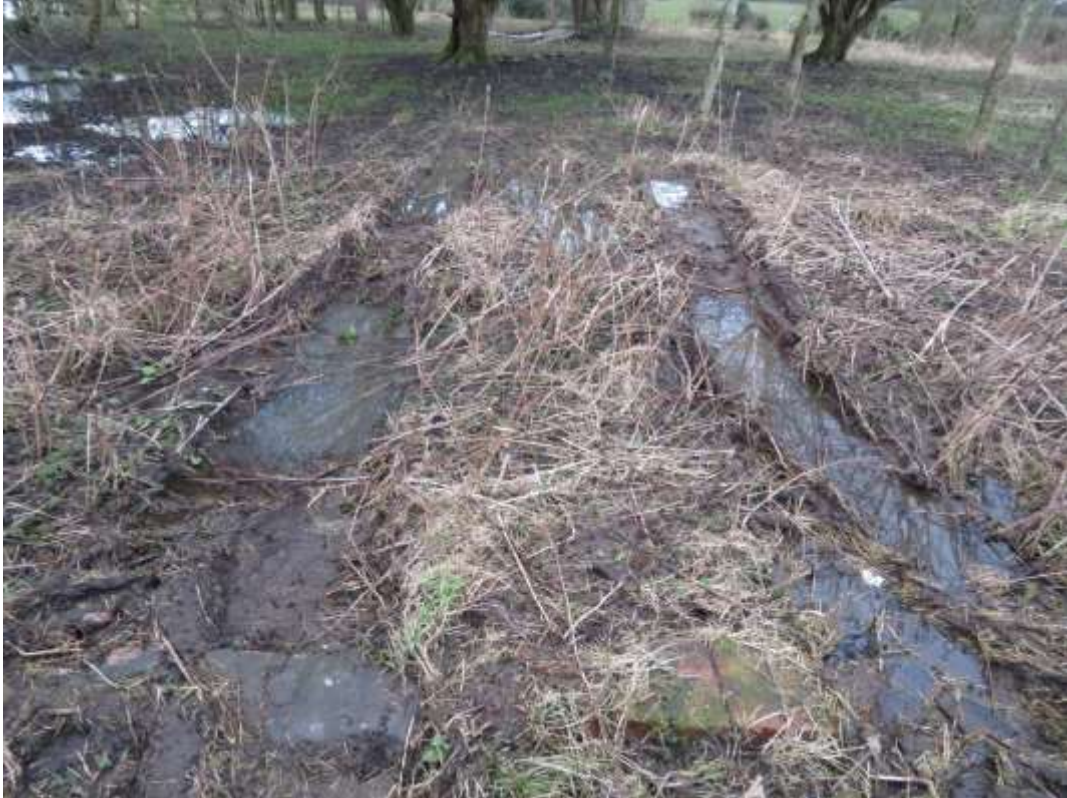
When the site was first visited in June 2019, much of the site was covered with scrub woodland and was heavily overgrown. Demolition material was still visible across some parts of the platform. However the site visit in January 2020 showed that some of the scrub had been cleared and there is evidence for vehicles being driven across the moat platform, which could have damaged any surviving archaeological remains (see Plate 7). Google Earth also shows that the site had regenerated scrub woodland on it, some of which has been recently cleared. This could cause erosion and means that the site is at risk from further damage.

*Plate 7 Vehicle tracks at Buttery House Farm, over building foundations shown in the foreground*

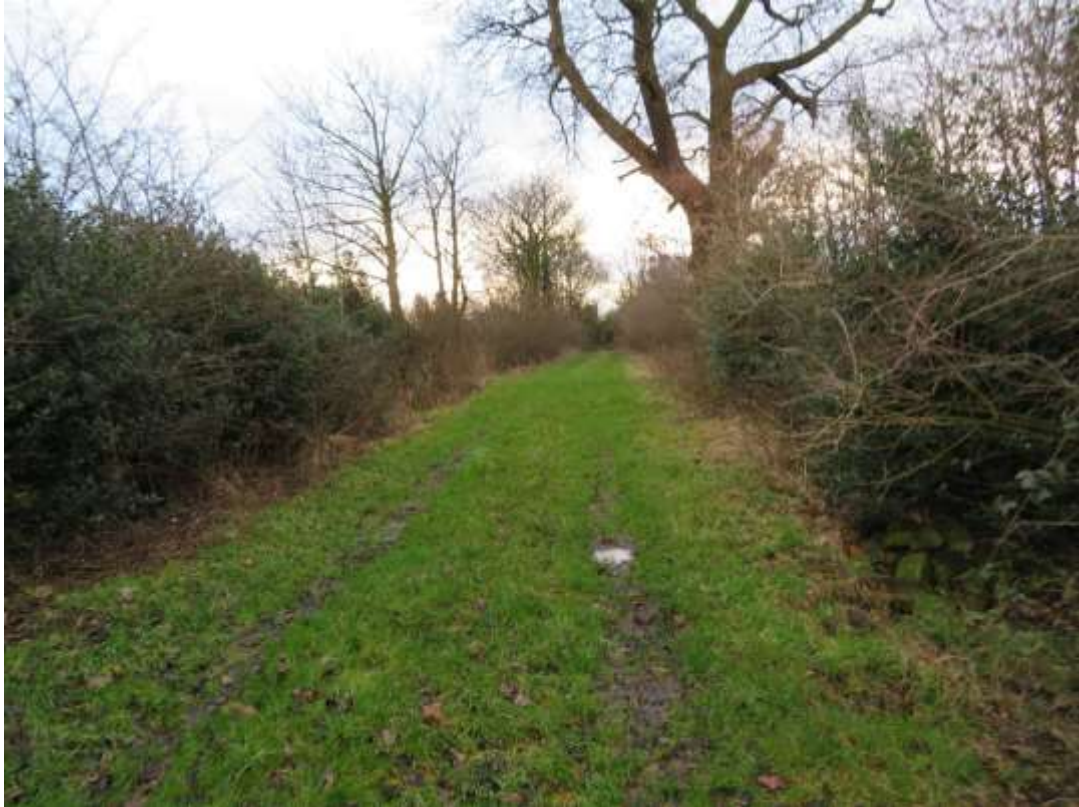
Other features relating to Buttery House Farm, is the survival of stone gateposts and also the track which leads to the former farm from Shay Lane. There is a possibility that this has always formed a routeway and could have originally served the moated site and the deer park.

*Plate 8 Buttery House Lane, looking south-east. This track may have some antiquity as it appears to have always served Buttery House Farm*

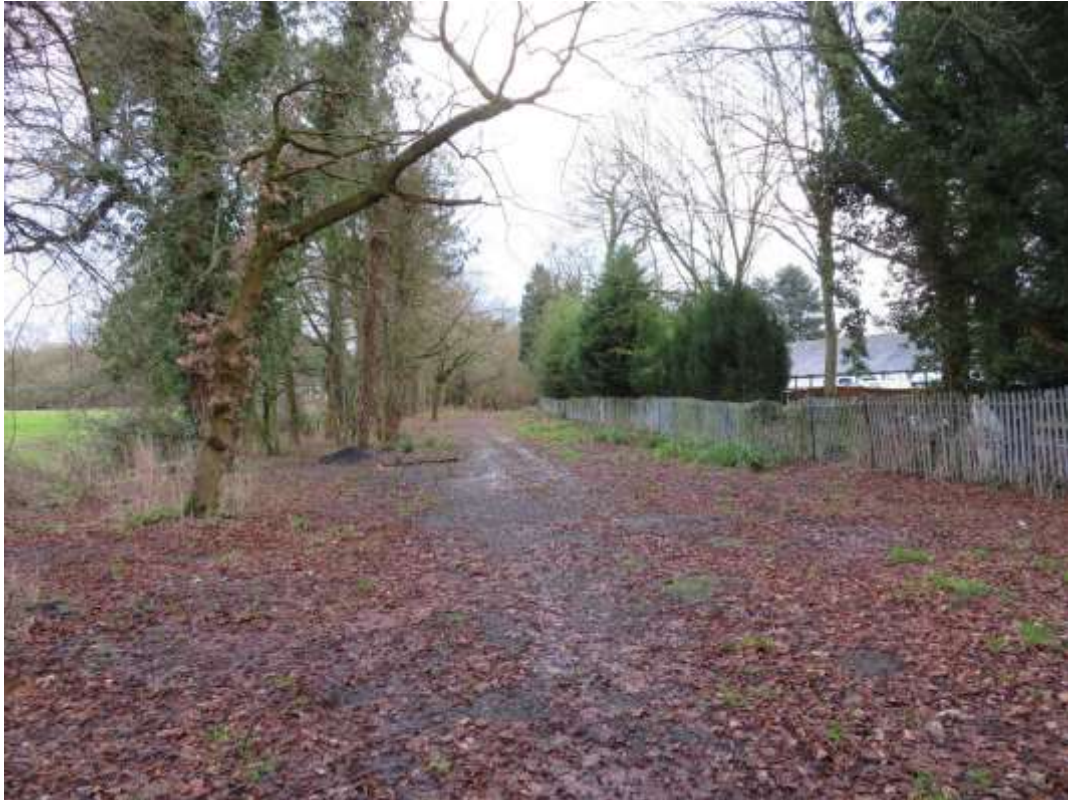
Two parts of the road run through the Site in a broadly north-south direction; the first part runs from Ridgeway Road in the north, towards Dobbinetts Lane, where it slightly changes angle and runs southwards to meet Whitecarr Lane and Roaring Gate Lane. This part is still fully open as a public footpath and still retains a hedge and tree line, although only a single hedge still remains with a compacted earth surface. The southern part of the Drive runs southwards from close to the junction of Roaring Gate Lane, Shay Lane and Thorley Lane and continues beyond the Site boundary towards Hale Barns to the south-west. It lies just outside the Site boundary, however it does have an integral relationship with it; the condition of the Drive has also been discussed within Appendix 3, in terms of its relationship with the listed Davenport Green Hall. The hedge no longer survives along this part of the Drive and a number of trees have been removed, thinning the plantation (Plate 11). In addition, a metal fence has been erected along the boundary between the Hall and the Drive (Plate 9) and a gate erected by the Brooks family is in poor condition (Plate 10).

*Plate 9 Looking south-west along Brooks Drive, showing the thin plantation, lack of hedge and inappropriate use of fencing materials*

The northern part of Brooks Drive is in good condition although the surface could be upgraded to allow more people to walk and ride along it. However there are poor connections with the wider road network within the Site as these are not pedestrian friendly. This should be looked at as part of a wider transport network whilst also respecting the contribution the roads make to the rural character of the landscape.

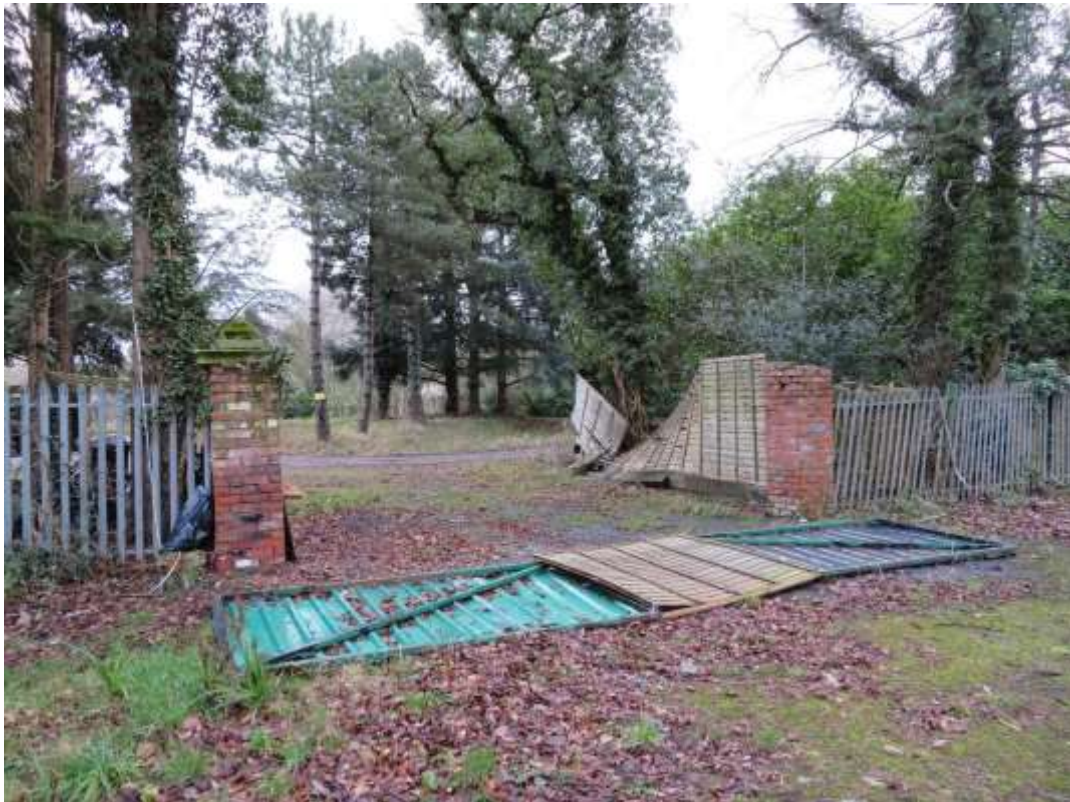
*Plate 10 The private gateway created by Samuel or William Cunliffe Brooks to lead onto Brooks Drive. It is currently in poor condition.*

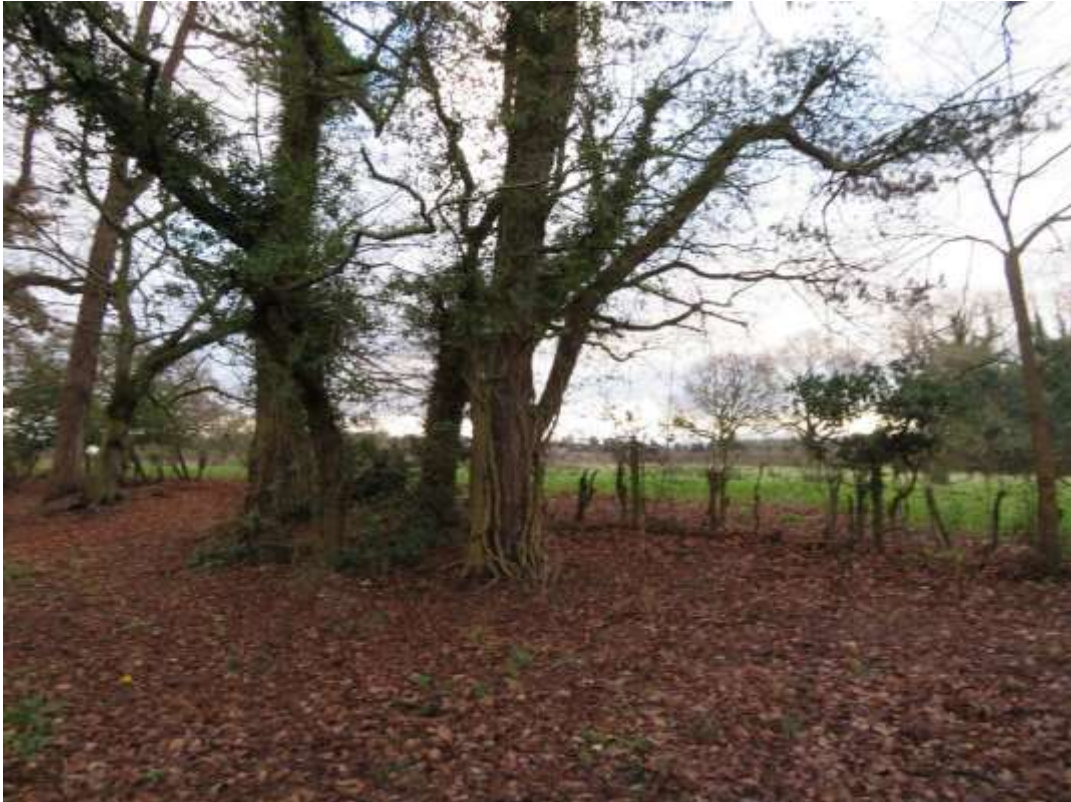
*Plate 11 The screening along the south-eastern side of the Drive is in poor condition and the original hedges no longer survive.*
