Historic Environment Assessment

Places for
Everyone Land
Allocations,
Rochdale

JPA21 Crimble Mill

Technical Report:
Rachael Reader

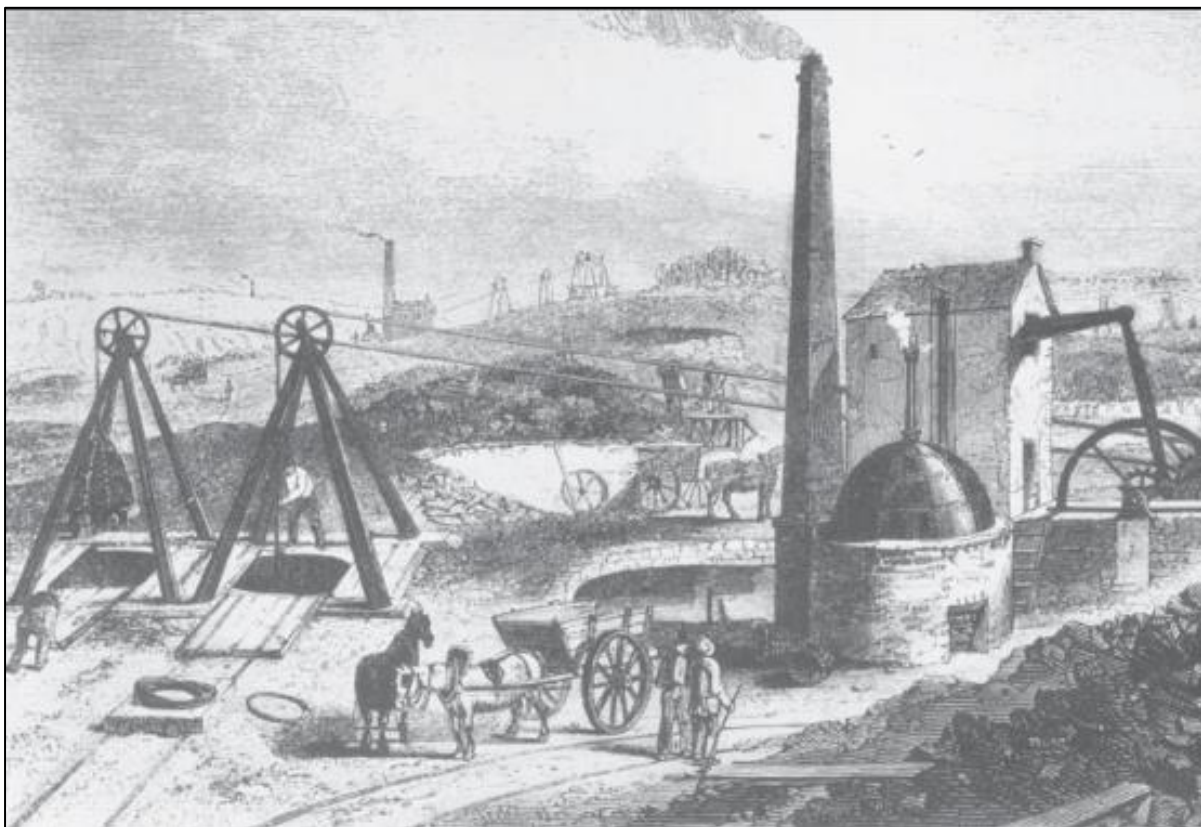
Plate 3 Example of a mid-19th century pithead and how Captain's Fold Colliery may have looked. A steam-powered beam engine on the right is winding the full and empty trolleys up and down the adjacent shafts (Miller 2012, 16).

According to the coal authority, there are two mine shafts within the Site which once entered into the colliery; the main one associated with the buildings identified on mapping and one along the banks of the River Roch, known as Bob Pit. The buildings associated with the colliery are likely to have consisted of a chimney, engine house and boiler house (Plate 3). These would have supplied power for pumping and winding engines associated with a downcast shaft. The small reservoir is likely to have supplied water for the boiler house.

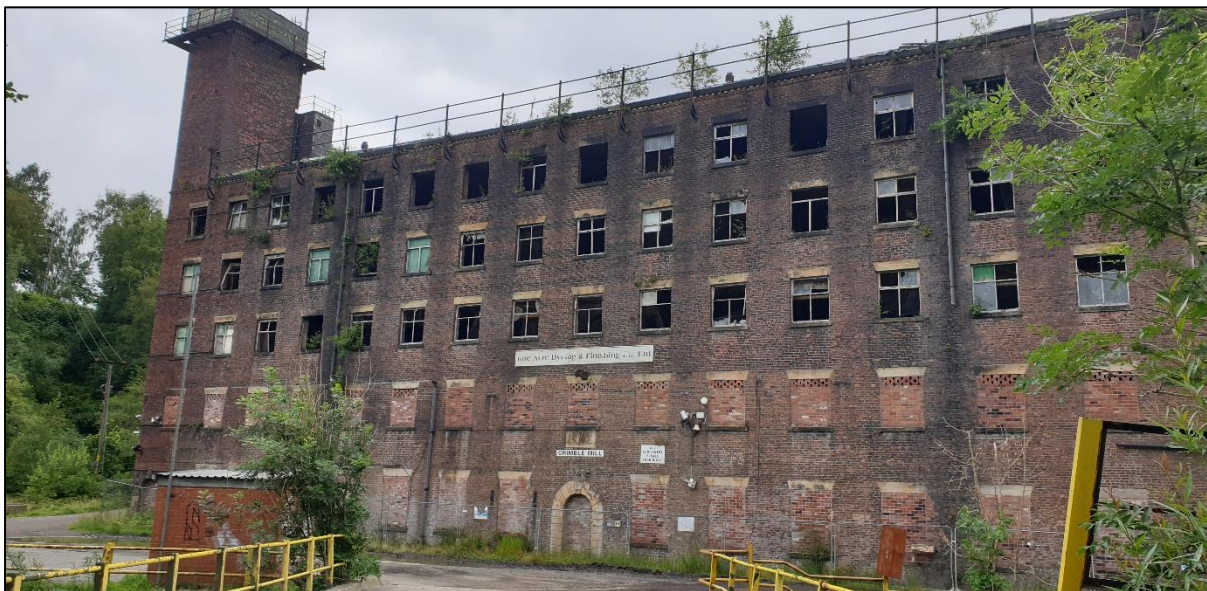
Plate 4 Crimble Mill Spinning Block, built around 1825 for Charles Stott

Inside, the mill is constructed with joisted timber floors supported by timber beams and cylindrical cast-iron columns. The tops of these have bolting faces on four sides for the line shafting. The lower four storeys have iron compression boxes to transfer the loads in the columns around the timber beams. Steel reinforcing joists are also used in places, possibly to support heavier machinery. The bottom storey has evidence for the original waterwheel pits in the form of two wide stone arches within the eastern elevation, within the centre of the building. The roof has a shallow pitch, with timber collar trusses. Further evidence for power transmission is found within the southern wall which abuts the later engine house. There are large cast-iron boxes for the upright shaft and bevel gears attached. These would have supported the horizontal shafts attached to the end wall within each storey.

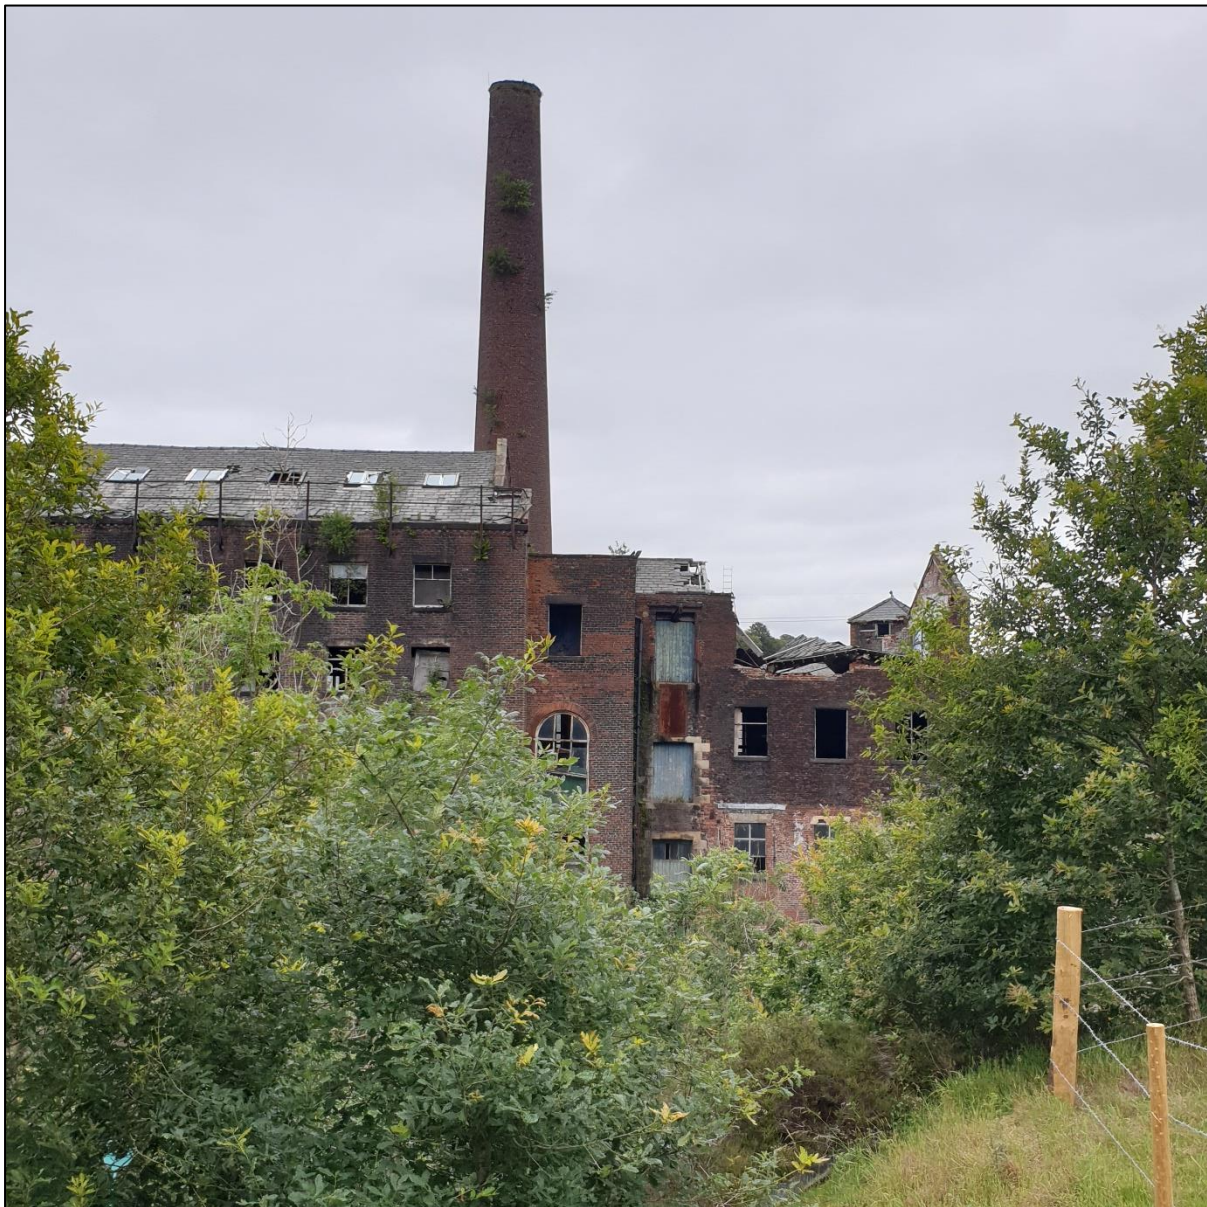
Plate 5 Crimble Mill: Engine House (with chimney to the rear) and the partially collapsed fireproof warehouse 1880s warehouse (Grade II)*

The warehouse is the same date as the engine house and is four storeys high and four bays wide, extending southwards from the engine house, which it is attached to (Plate 5). It has rectangular windows, similar to the spinning mill although taller and original taking-in doors are preserved within the first bay of the western elevation. These have stone sills and lintels,

with quoined stone jambs; a further taking-in door on the top floor has been converted from a pre-existing window. The floors inside are of fireproof construction, with transverse brick jack-arches supported by cast-iron beams and a single central row of cast iron columns. The attic consists of reused floor beams with a king-post truss and diagonal braces. There is also a large lead lined water tank at the north end and evidence for power transmission in the form of bearing boxes in the north wall adjoining the engine house. In June 2019, part of the roof structure collapsed and emergency works involved the removal of the slates, broken trusses and upper part of the floor removed to windowsill height.

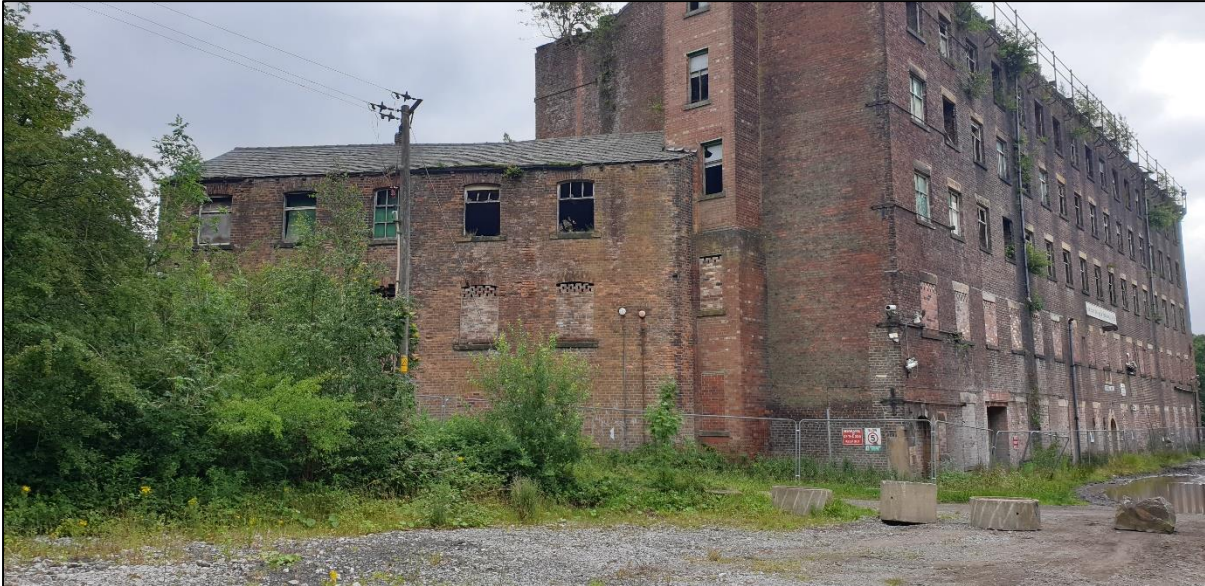
Plate 6 1880s warehouse, attached to the 1825 spinning block

This warehouse abuts the northern side of the spinning block and is believed to have been added when James Kenyon converted the complex from cotton to woollen production (Plate 6). This is also brick built and built at an angle to the spinning block. It is narrower at its northern end and the eastern elevation is supported on a riveted iron beam above basement level. It also has a partial basement and is a maximum 5 bays (west side) and 3 bays (east side).

Most of the windows have segmental brick arches and stone sills. There is a taking-in door within the western elevation with a projecting steel hoist beneath the lintel. Inside, there are timber floors with timber cross beams supported by cast-iron columns within the basement. Like the spinning mill, the column tops have bolting faces on four sides and some of the line shafting remains *in situ*.

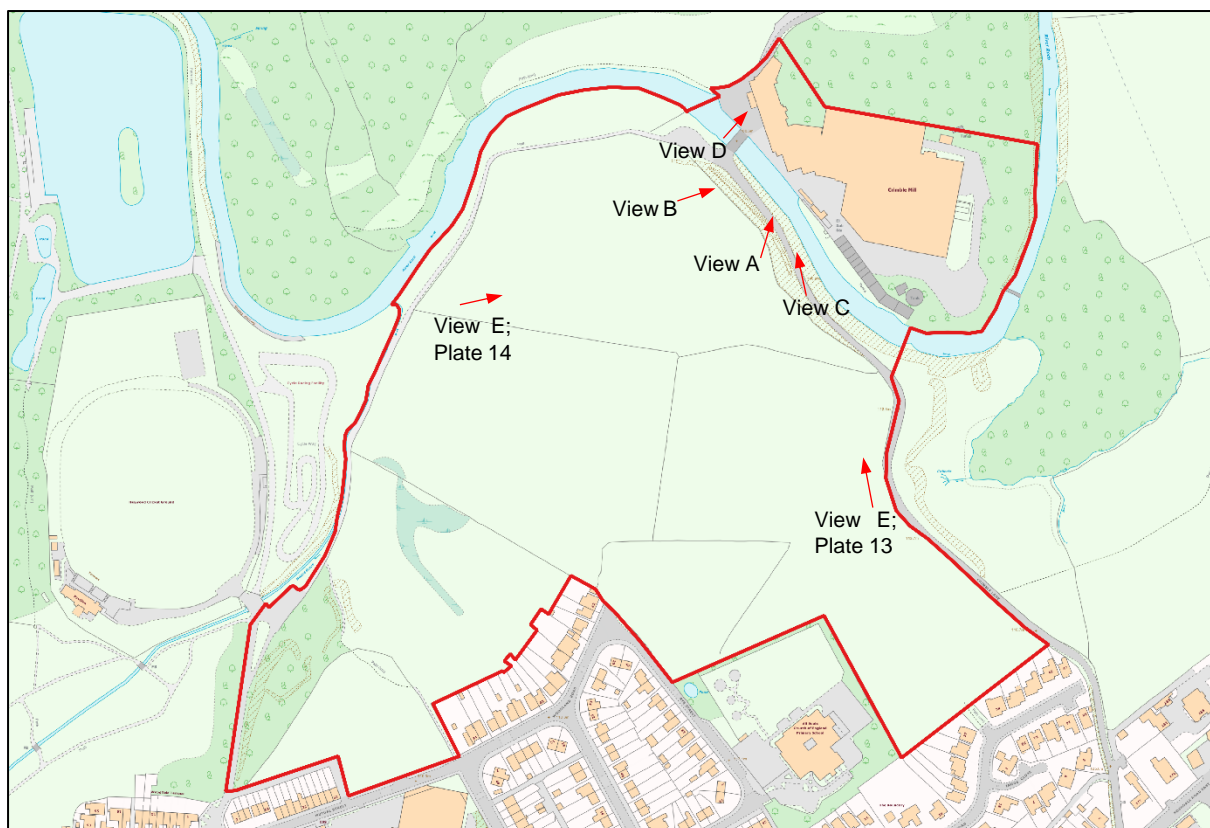
Plate 7 Key views of Crimble Mill

The key views of Crimble Mill are described below, with the location from which the key views are viewed shown in Plate 7. The magnitude of impact is also given within this section.

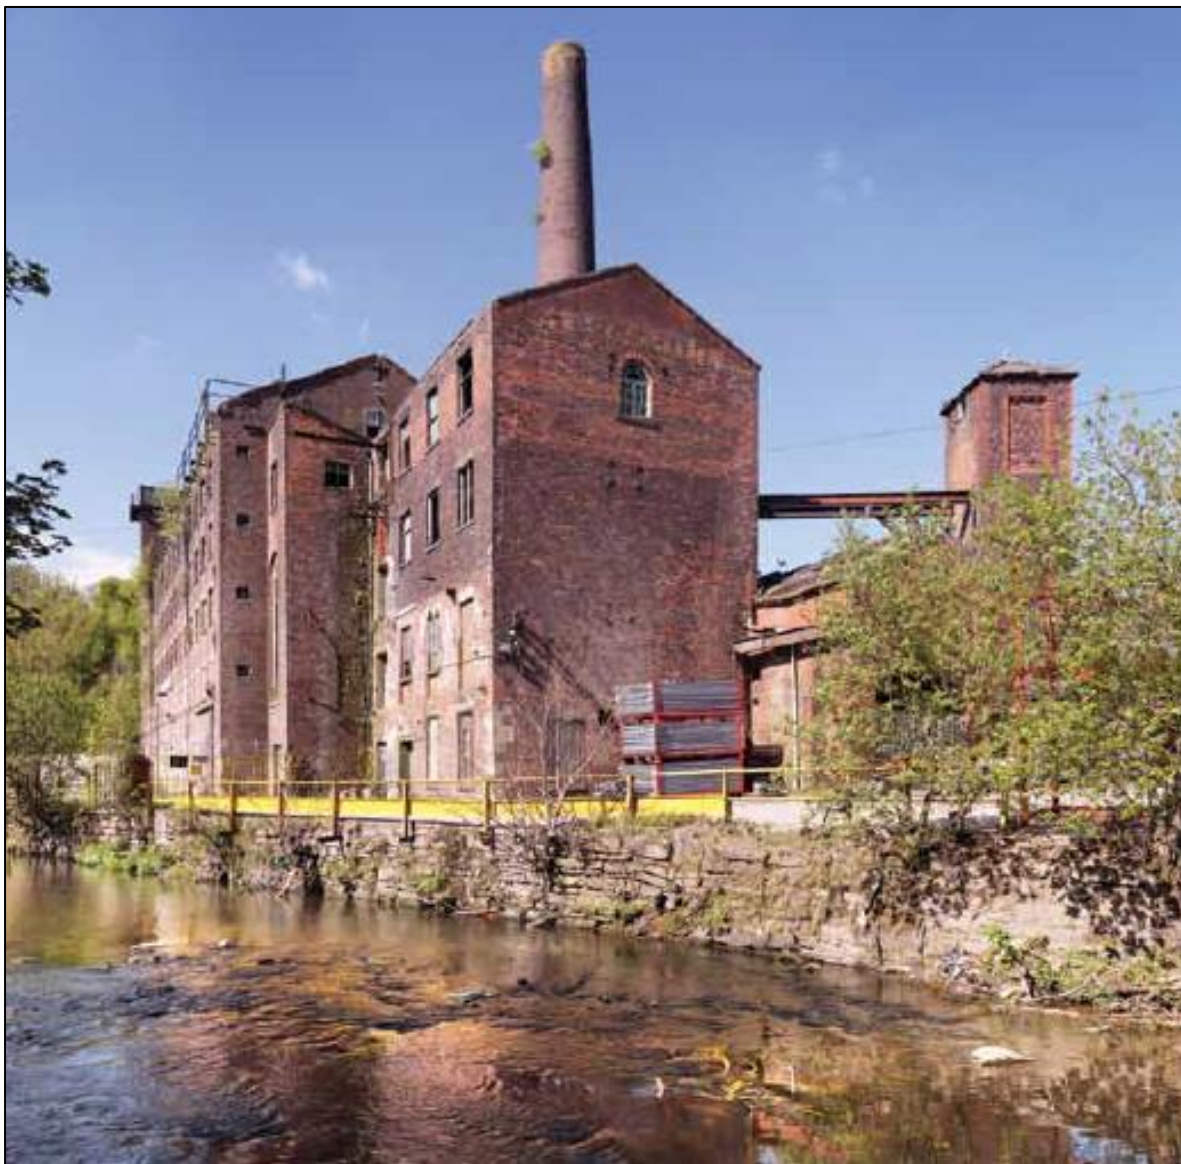
Plate 8 Looking north towards Crimble Mill from the River Roch

One of the key viewpoints of Crimble Mill is the view from the River Roch, looking north towards the mill (Plate 8). This view incorporates the grade II* listed spinning mill building and engine house, and the grade II listed chimney, as well as the boiler house. The river retaining walls can also be seen in the foreground, along with the River Roch itself, which has an association with the mill's early history as a water-powered mill. This view is also visible from Crimble Lane, however, this is presently obstructed by vegetation (Plate 9).

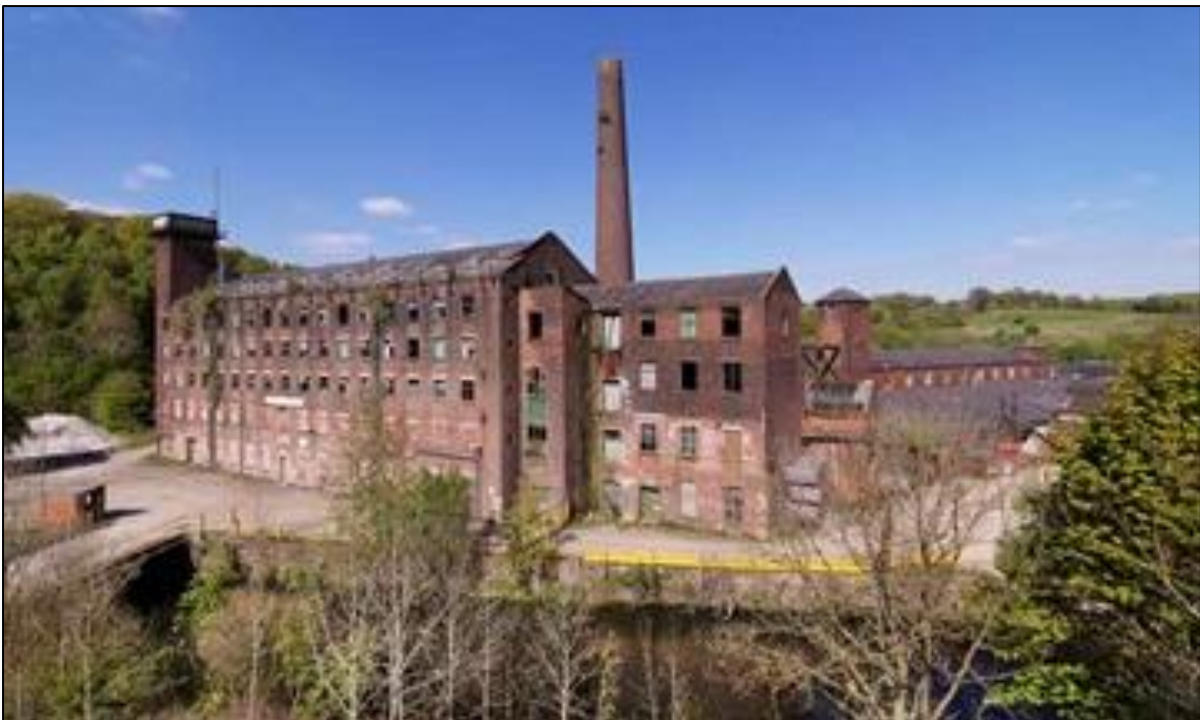
Plate 10 Looking east towards Crimble Mill from within the Site

One of the key viewpoints of Crimble Mill is the view looking towards Crimble Mill from the land to the west of the mill (Plate 10).

This view incorporates the grade II* listed spinning mill building and engine house, and the grade II listed chimney, as well as the boiler house and early 20th century sheds.

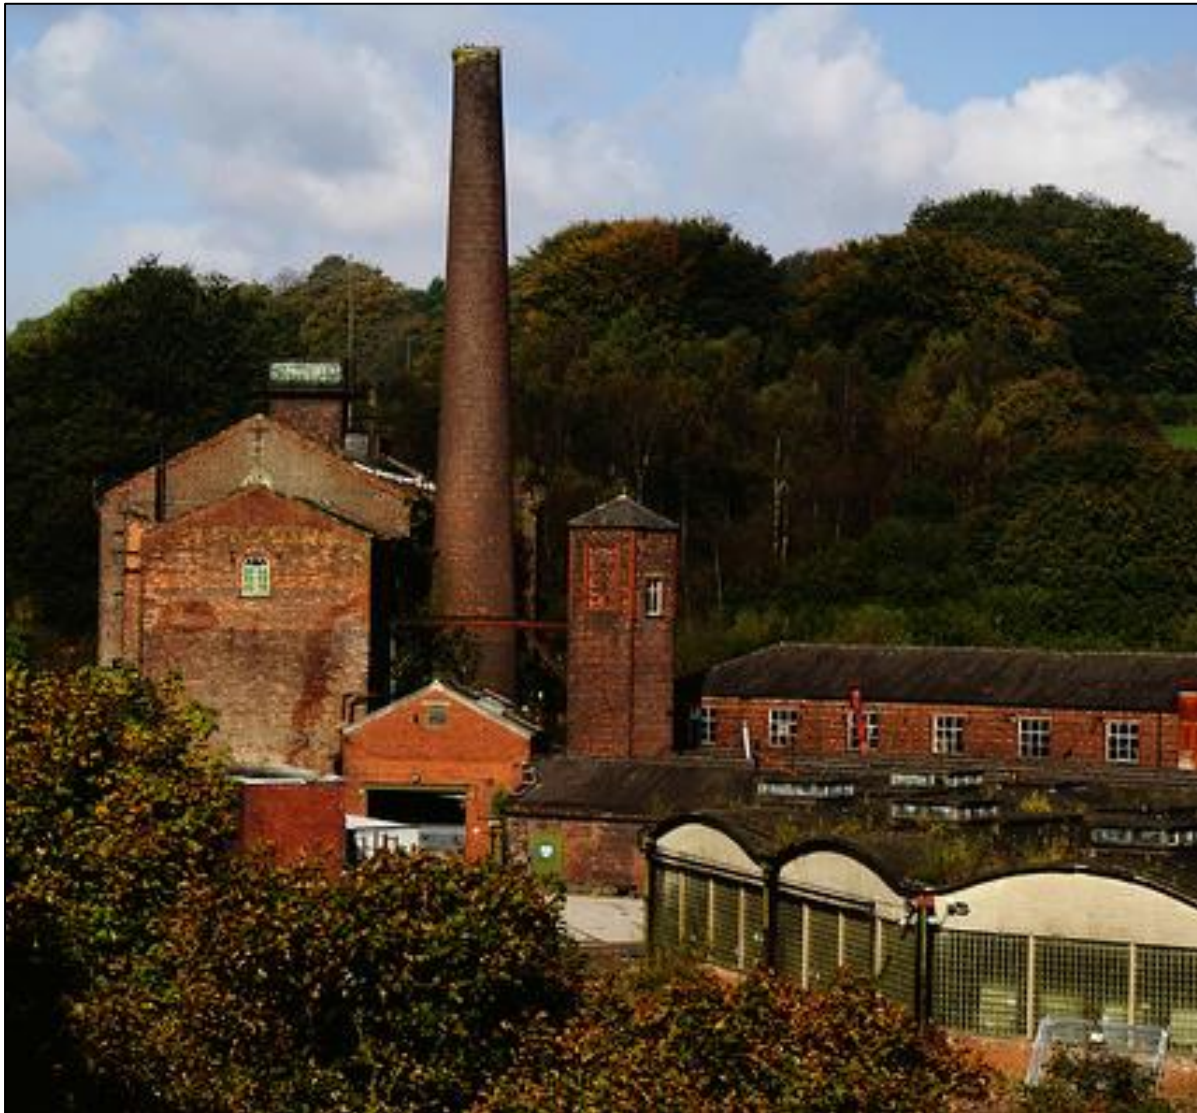
Plate 11 Looking north towards Crimble Mill from Crimble Lane

One of the key viewpoints of Crimble Mill is the view looking north towards Crimble Mill from Crimble Lane, to the southwest of the River Roch (Plate 11). This view incorporates the grade II* listed spinning mill building and engine house, and the grade II listed chimney, as well as the boiler house and 20th century sheds.

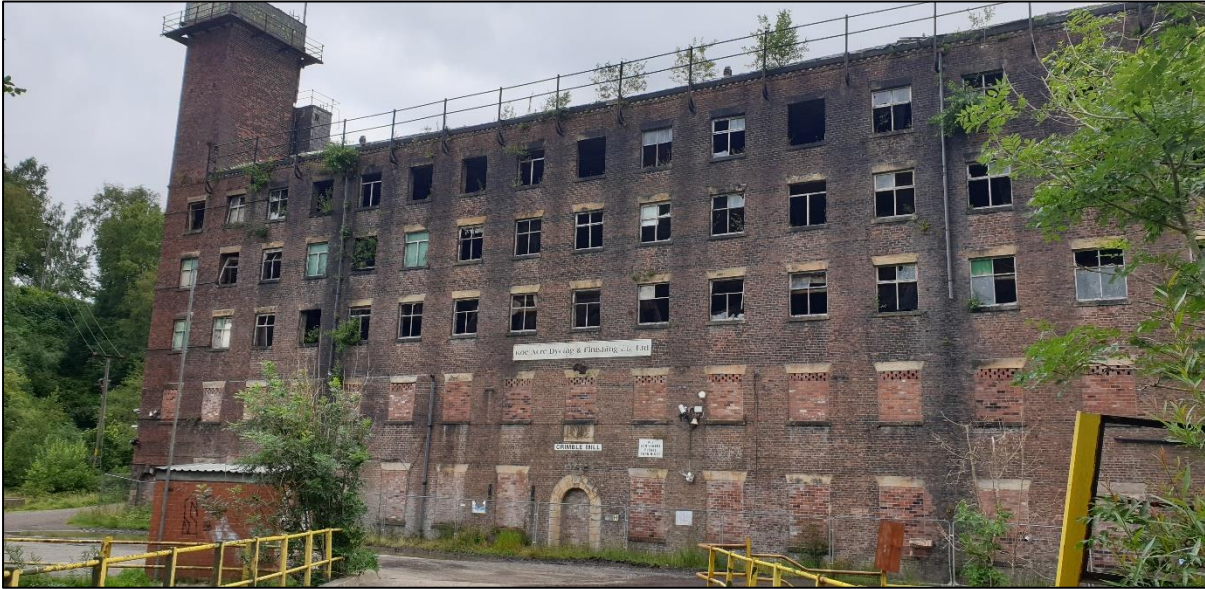
Plate 12 The c. 1825 spinning block at Crimble Mill, looking east from the bridge over the River Roch

The view looking east from the bridge over the River Roch is a key view of the grade II* listed spinning mill (Plate 12). The arched entrance to the spinning mill is located within the centre of the view. Development on the land within the Site, to the west of the mill, will not affect this view. The redevelopment of the mill, if sensitive to the mill's character, has the potential to enhance this view through restoration of the mill.

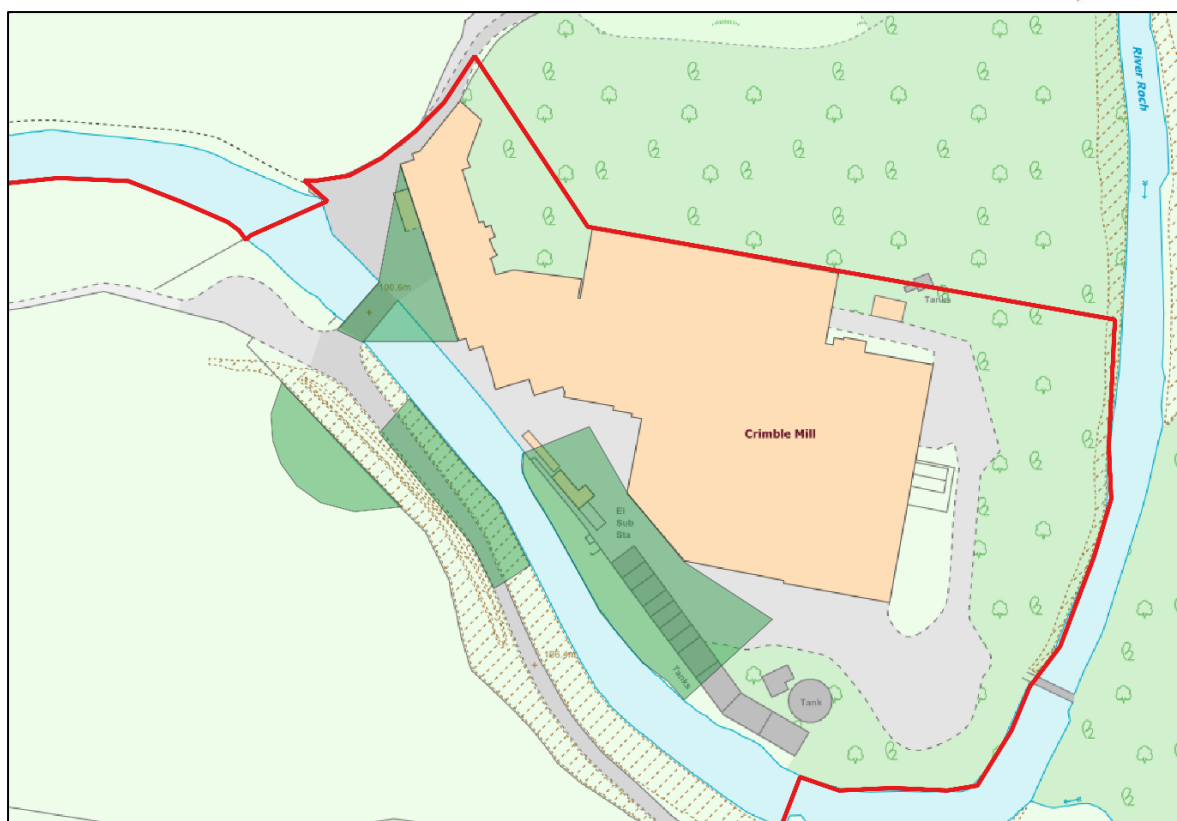
Plate 16 Areas which can be used as open space/viewing platforms and landscaped to enhance the views of Crimble Mill (shown in green)

- Any restoration or redevelopment of the mill should be sympathetic to its historic character
- Development is not recommended immediately west/south-west of the mill in order to preserve key views of the spinning block in particular (Plate 15; Figure 7). Instead, viewing platforms, or open spaces, may be incorporated into the scheme's design to maintain the key views of Crimble Mill (Plate 16; Figure 8).

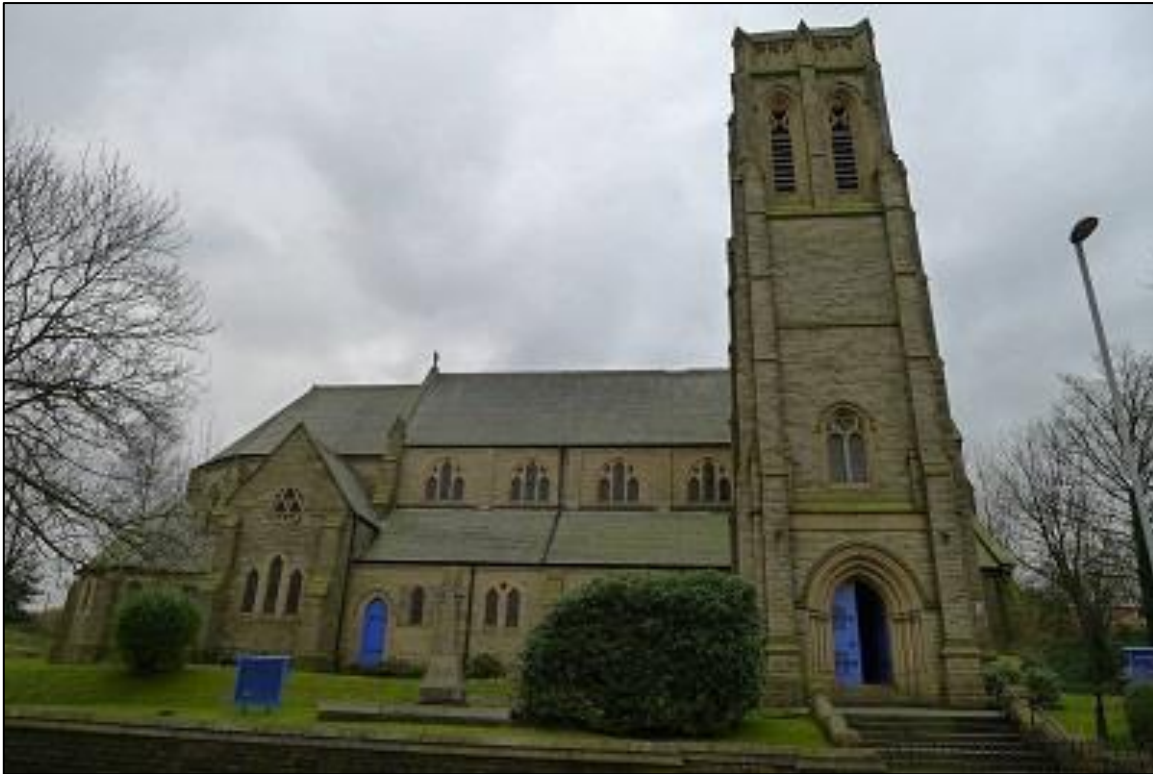
Plate 17 Church of All Souls (© Archbishop's Council)

The Church of All Souls lies to the south of the Site, on the south side of Rochdale Road East and was built in 1898-9 to designs by F.P. Oakley, with a tower added in 1908 (Plate 17). It is constructed of coursed rock-faced stone with a slate roof and is of a Geometric Gothic style. It has a nave with clerestory, aisles, a tower to the north and a porch. The polygonal apse has a hexagonal vestry to the north and a chapel to the south. The church recently closed and is no longer in active use for worship.

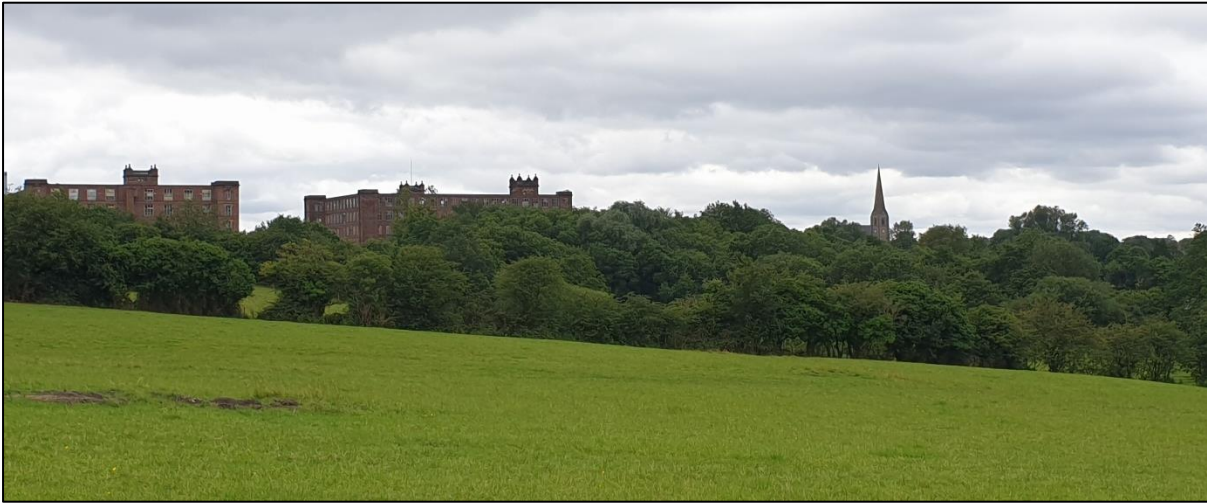
Plate 18 From left to right, Mutual Mills No. 3, No. 2 and Church of St. Luke, looking south-west

Views of Mutual Mills from the wider area are fairly limited, however it can be experienced in kinetic views from the surrounding townscape. There are views from within the Site as well, predominantly the spinning blocks of Mills No.2 and 3 and moving through the Site allows a visual appreciation of both Mutual and Crimble Mills, although there appears to be no intentional inter-visibility (Plate 18). Despite limited views, the mills contrast starkly with both the predominantly low rise setting to the south, east and west and the rural landscape to the north and north-east. The mills contribute to the prevailing townscape and their continued
